# STRUCTURAL TESTS OF PLASTIC FRANGIBLE COUPLINGS

Bret B. Castle

JANUARY 1977

FINAL REPORT

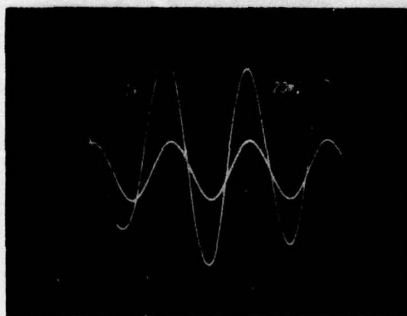
76-20 12

A. NATURAL VIBRATIONS

B. CENTER SECTION OF A

C. FREQUENCY COMPARISON

D. NATURAL VIBRATIONS

E. CENTER SECTION OF D

F. FREQUENCY COMPARISON

FIGURE 12. TYPICAL OSCILLATIONS FOR FRANGIBLE COUPLINGS

RESONANT FREQUENCY TEST. No specification value was required to be met in this test. The results indicated that the standard 4-foot PAR-56 lamp assembly with the standard frangible coupling had a resonant or natural frequency of 16.5 hertz, and the 4-foot PAR-56 lamp assembly, including a plastic frangible and interface coupling, had a resonant or natural frequency of 6 hertz. Oscilloscope pictures of the typical oscillations were taken, and the results

are shown in figure 12. A comparison of the photographs shows the difference in amplitude, ringing, and frequency between the assembly with the standard aluminum coupling (figure 12A, B, and C) and with the plastic coupling (figure 12D, E, and F). Figures 12A and D show the damped oscillations of the assemblies with the standard frangible coupling and with the plastic frangible coupling, respectively. Figure 12B and E show blown-up center sections of figure 12A and D, respectively, while figure 12C and F compare the natural frequencies with the input of the frequency generator. In figure 12C, the calibrated frequency is the small (2 centimeters) sine wave at 16.5 hertz, and the large sine wave is the oscillations of the lamp assembly. In figure 12F the calibrated frequency is the lower sine wave at 6 hertz, and the upper waveform is the oscillations of the lamp assembly. The plastic frangible coupling produced a more damped oscillation and a lower natural frequency than did the standard aluminum frangible coupling.
